Locating Leaks

Infrared technology can help uncover roof moisture problems

By Jeffrey L. Gadd | Photos courtesy of Vision Infrared Services

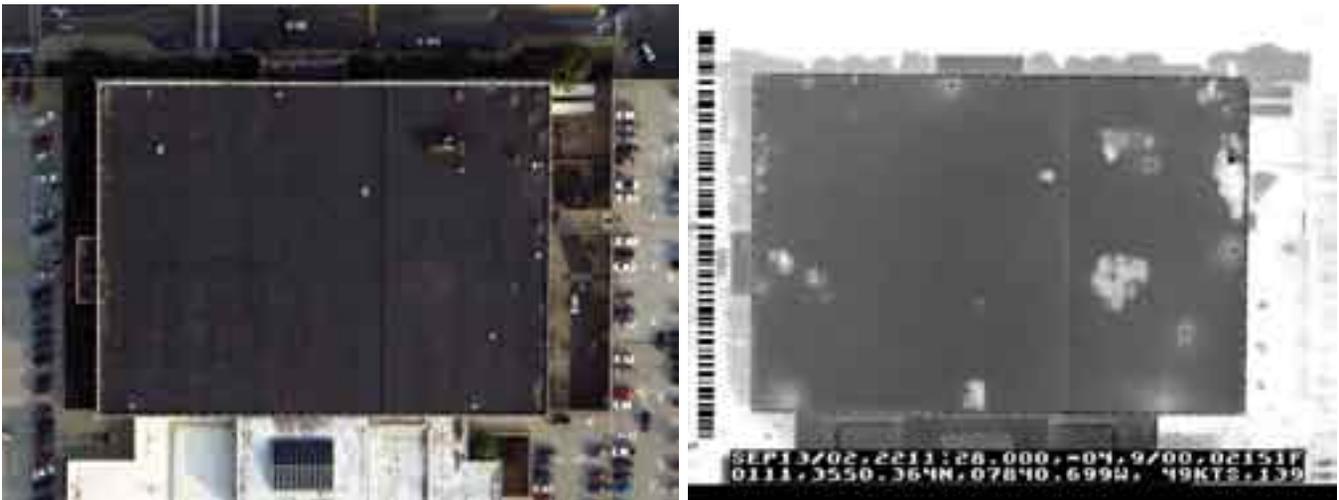
TWO VIEWS Infrared imaging (right) can reveal problem spots on roofs not normally visible to the naked eye (left).

During the day, the sun radiates energy onto the roof and into the roof substrate, and then at night, the roof radiates the heat back into outer space. This is called radiational cooling. Areas of the roofs that are of a higher mass (wet) retain this heat longer than that of the lower mass (dry) areas. Infrared imagers can detect this heat and “see” the warmer, higher mass areas, during the “window” of uneven heat dissipation.
